# Manhole Inspection Summary

Manhole # S13M\_\_001MH

Insp Date: **3/25/08 12:47 PM**

**Location** Address: **McTeague**

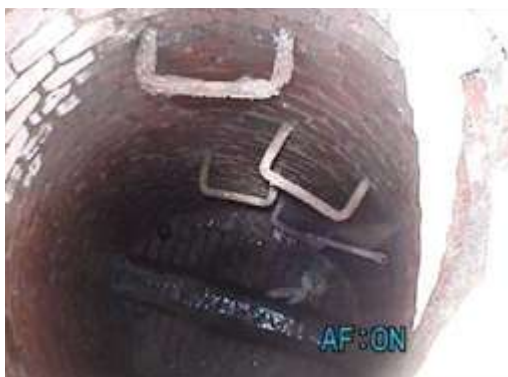
Defect 4

**Steps** Count: **4** Missing: **0** ☒ **Corroded**

steps corroded

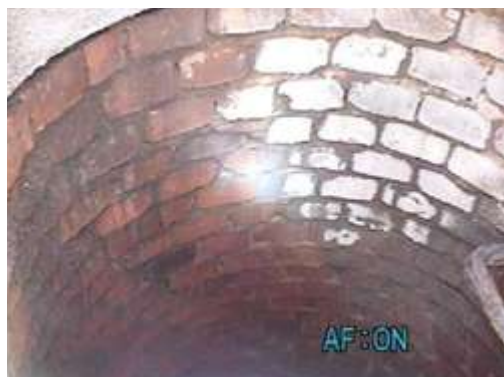
Defect 3

Condition: ☐ Sound ☒ **Cracked** ☐ Root Intrusion ☐ Loose Brick ☐ Deteriorated

Infiltration: ☐ None ☐ Joint ☒ **Cracks** ☒ **Mortar** ☐ Roots ☒ **Wall**

corbel cracked, infiltration at cracks and mortar

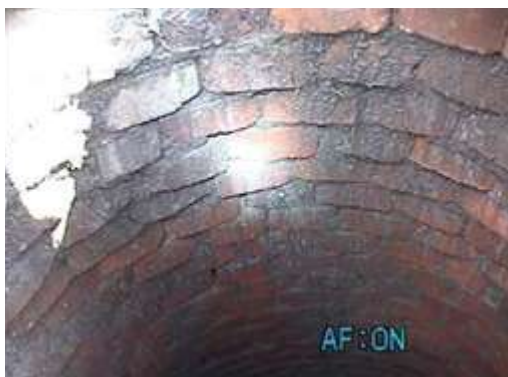
Defect 2

chimney infiltration mortar

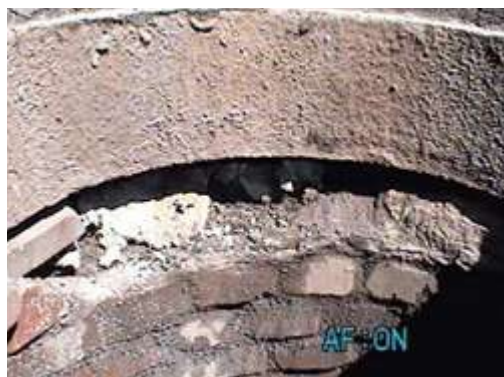
Defect 1

Condition: ☐ Sound ☐ Cracked ☐ Root Intrusion ☒ **Loose Brick** ☒ **Deteriorated**

Infiltration: ☐ None ☒ **Joint** ☐ Cracks ☒ **Mortar** ☐ Roots ☒ **Wall**

chimney loose bricks, deteriorated, joint infiltration

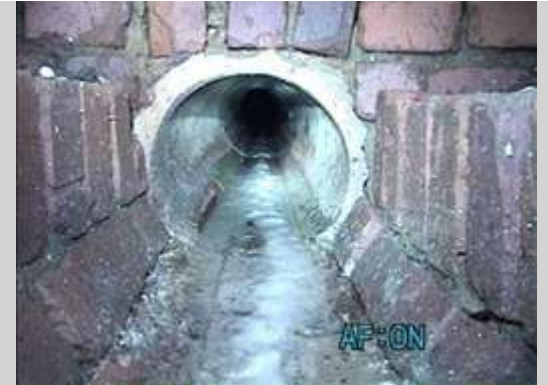
12 O'Clock Outflow

Pipe Height: **8.4** (in.) Rod and Bar (Angled)  
Pipe Material: **Clay** ☐ Pipe Lined  
Invert Depth: **9.20** (ft.) Flow Characteristics: **Slow**  
Deposits: ☒ None ☐ Mud ☐ Sludge ☐ Debris ☐ Grease  
Silt Depth: **0** (in.) Deposits Extent:  
Infiltration: **None** Pipe Seal Cond: **Sound**

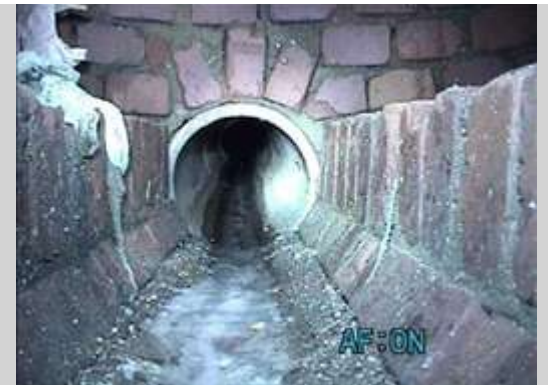
6 O'Clock Inflow

Pipe Height: **8.4** (in.) Rod and Bar (Angled)  
Pipe Material: **Clay** ☐ Pipe Lined  
Invert Depth: **9.29** (ft.) Flow Characteristics: **Slow**  
Deposits: ☒ None ☐ Mud ☐ Sludge ☐ Debris ☐ Grease  
Silt Depth: **0** (in.) Deposits Extent:  
Infiltration: **None** Pipe Seal Cond: **Sound**
